September 2012

# **EU2000iK1 GENERATORS**

## **SAFETY AND EMISSIONS RECALL - STOP SALE/RENTAL NOTICE**

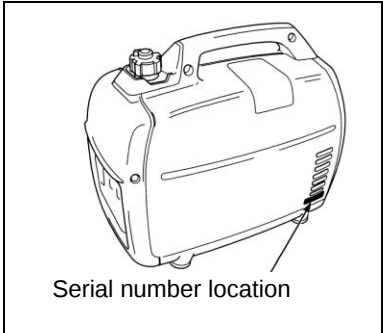
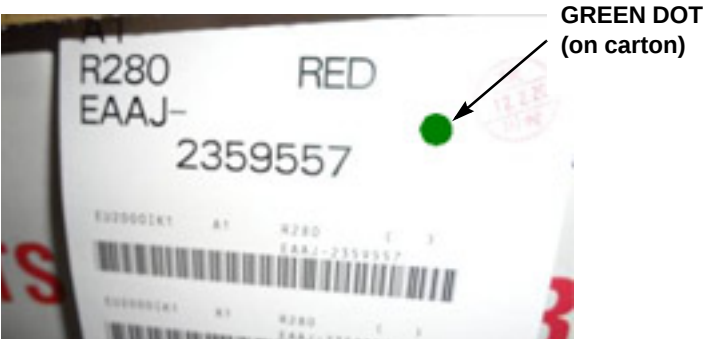
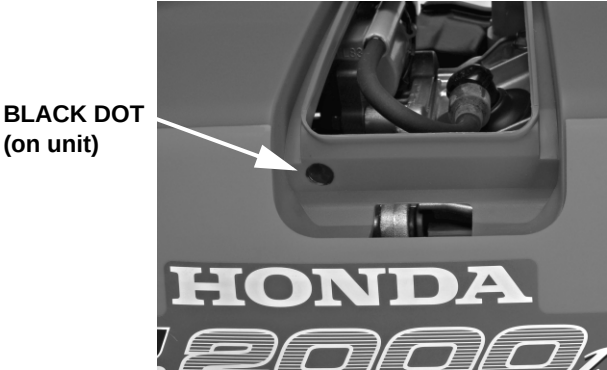
Units within the affected serial number range may have an improperly positioned fuel tube clamp at the fuel tank outlet. The tabs of the improperly positioned fuel tube clamp could wear into an adjacent fuel tube causing a fuel leak.

- Inspect your inventory and confirm if you have any generators within the affected serial number range. If you identify in-stock units, follow the *Dealer Inventory Inspection* procedure on page 2.
- Units within the affected serial number range cannot be sold, or otherwise placed into service, until they have been inspected and if necessary repaired, as required by law. Any injury or damage which occurs from affected units sold after this Stop Sale Notice is the responsibility of the retailer.
- American Honda will be issuing a service bulletin shortly with inspection and repair procedures.
- New units in American Honda inventory within the affected serial number range that have a green sticker on the carton next to the bar code and have a black "DOT" located under the spark plug access panel, have their clamps properly positioned and are not part of this stop sale notice.

American Honda is announcing a Stop Sale Notice of certain EU2000iK1 generators. Any new or used units in dealer inventory must be inspected and, if necessary, repaired prior to sale.
