Werner General Ladder Inspection Guide

Werner Ladder Inspection Guide: Ladder Anatomy

Examples of Damages: Ladders to be tagged and field destroyed*

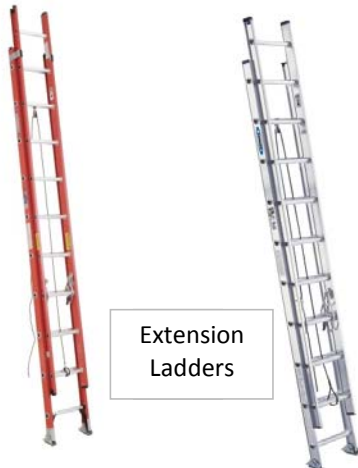
Extension Ladders

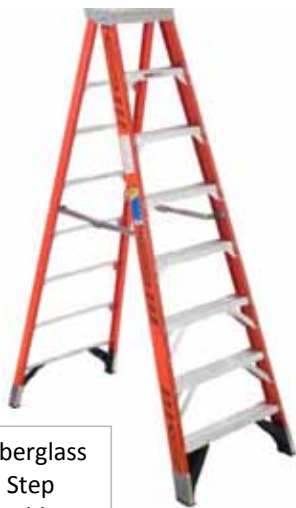
Fiberglass Step Ladder

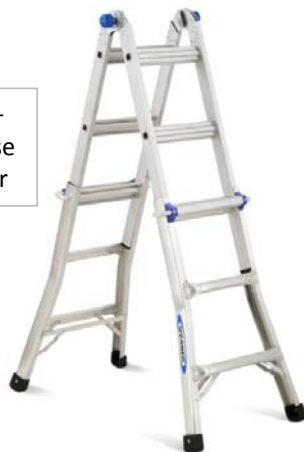
Multi-Purpose Ladder

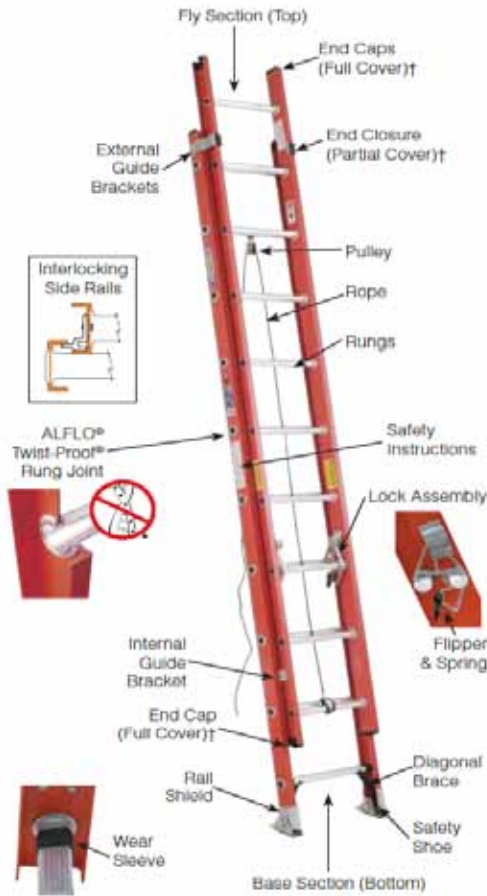
Fiberglass Extension Ladders

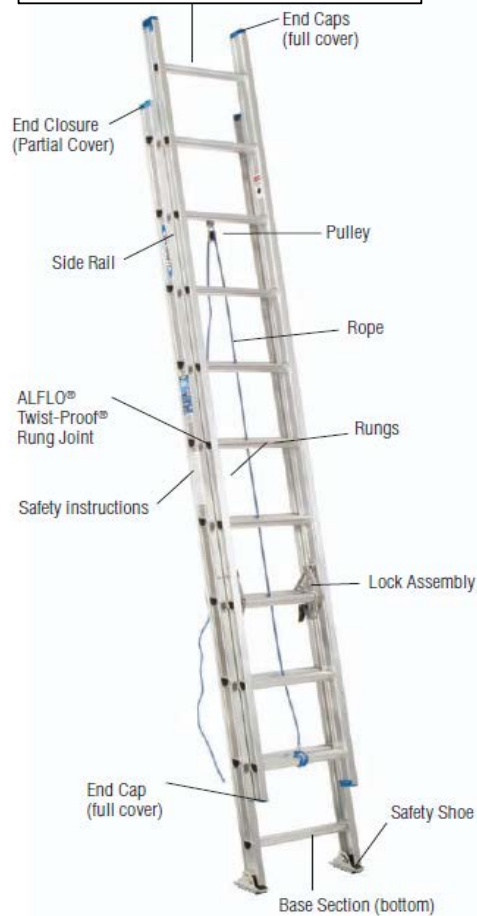
Aluminum Extension Ladders

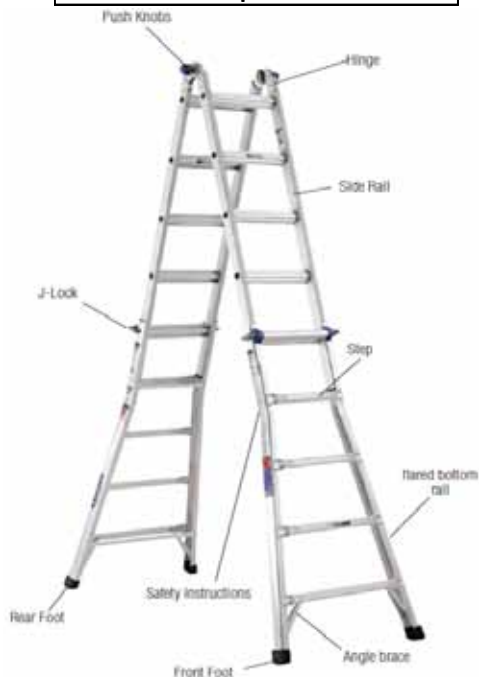
Multi-Purpose Ladders

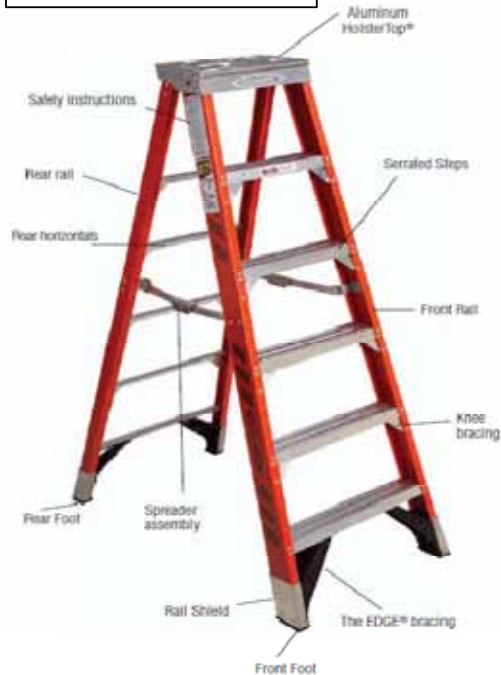
Fiberglass Step Ladders

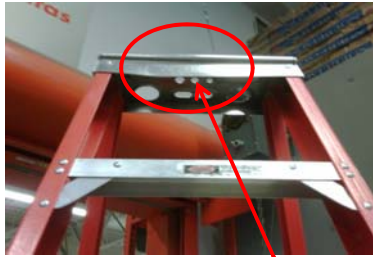
Bent Top

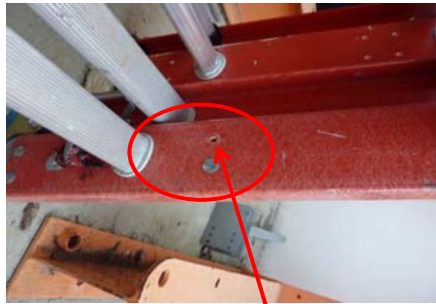
Missing Rivet

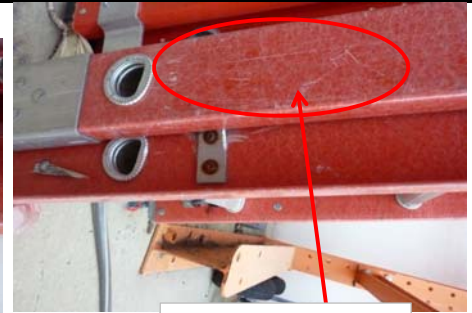
Cracked Fiberglass Rail

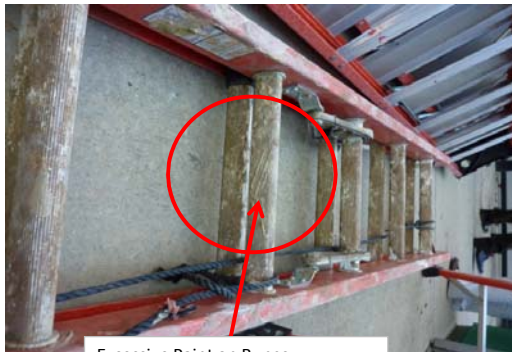
Excessive Paint on Rungs

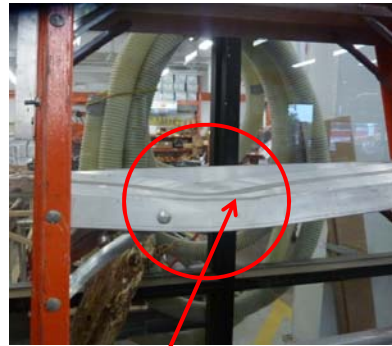
Bent Step

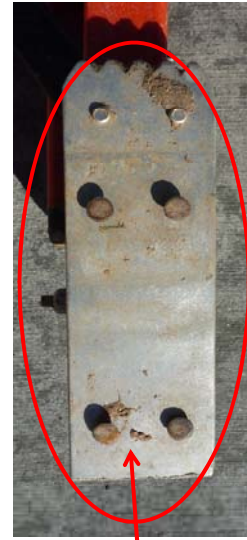
Missing Rubber on Foot

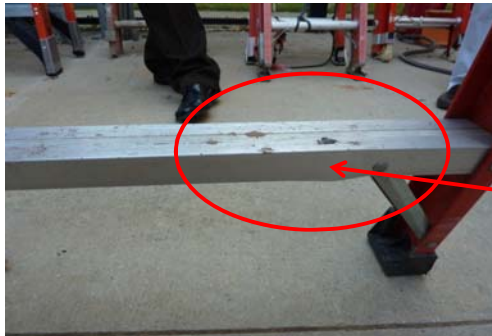
Bent step by bracing

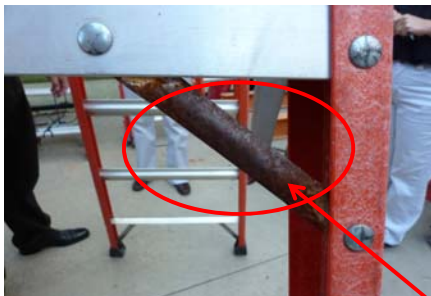
Pitted Rust

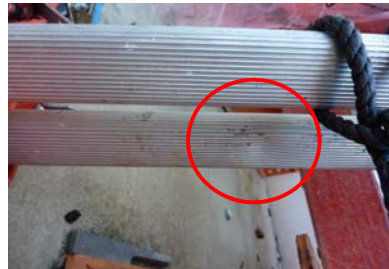
Bent Rung

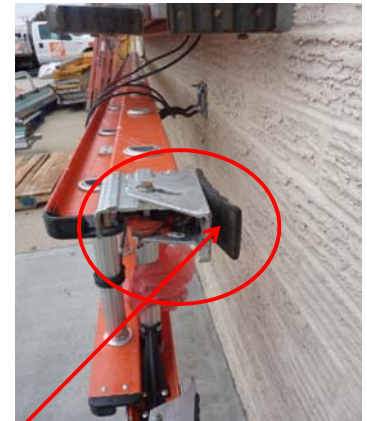
Damaged Safety Shoe : Rubber Pad Damaged
